• Oatey Fix-It Flange Repair Ring

• Oatey Fix-It Flange Repair Ring Design

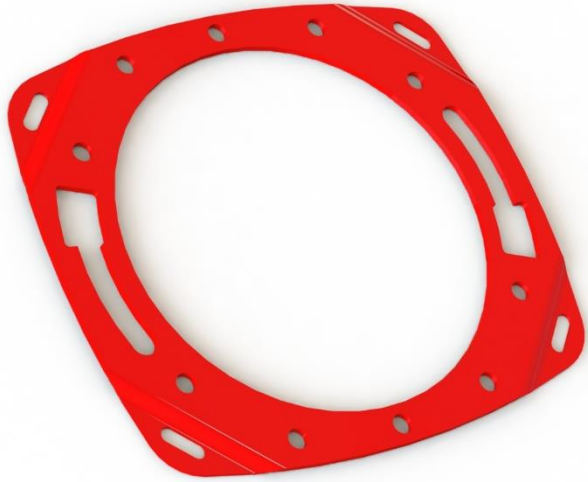
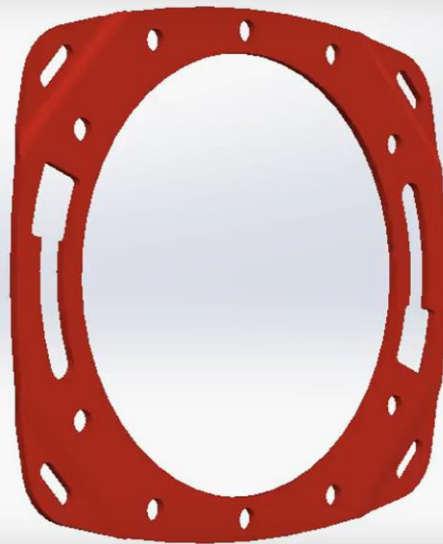
- Stronger Design
- Optimized Size
- Multiple Attachment Options for Secure, Level, Long Lasting Repairs
- The Oatey repair flange is designed for installation strength and is robust, with more mounting options, and a profile that is less obtrusive.

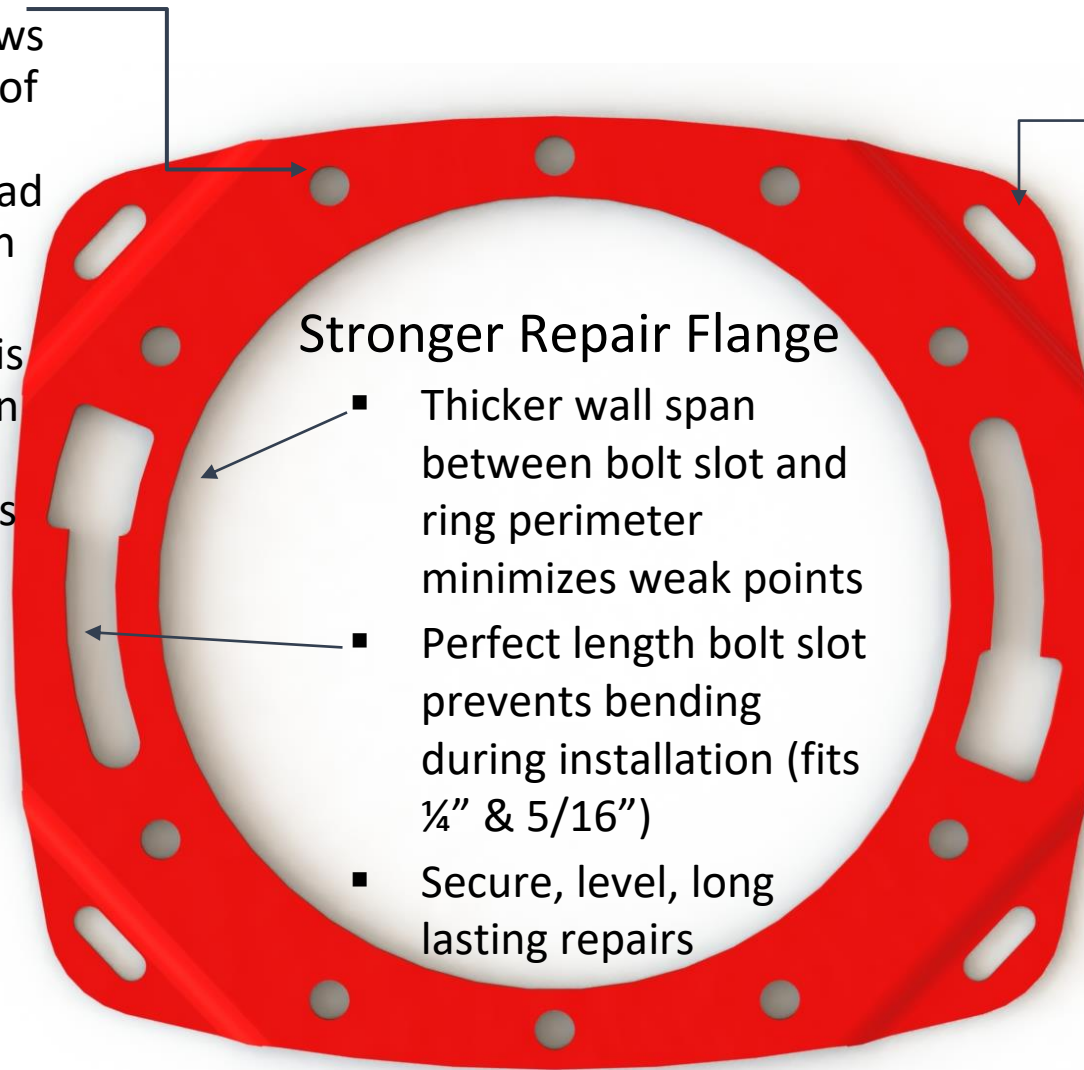
10 Mounting Holes

- Placement allows for wide range of installation options for broad scope of broken closet flanges
- Hole diameter is 0.26" to fit even larger tapcon concrete screws

Stronger Repair Flange

- Thicker wall span between bolt slot and ring perimeter minimizes weak points
- Perfect length bolt slot prevents bending during installation (fits 1/4" & 5/16")
- Secure, level, long lasting repairs

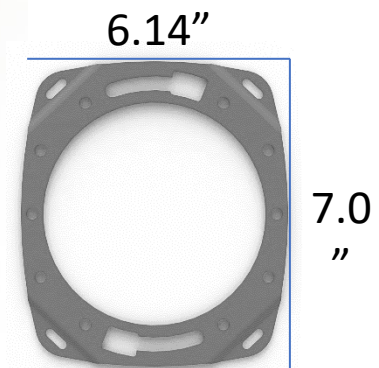
4 Slotted Tabs

- Tabs sized to fit under base rim for secure connection
- Elongated slots allow for angled screw "grab" to sound flooring
